**NAIROBI CITY COUNTY ASSEMBLY
SECOND ASSEMBLY-SECOND SESSION**

**REPORT
OF THE SECTORAL COMMITTEE ON
TRANSPORT AND PUBLIC WORKS
ON _____**

**THE COMMITTEE'S SITE INSPECTION VISIT TO KWA REUBEN,
MIHANG'O, KOMAROCK AND UMOJA 1 WARDS**

JULY, 2018

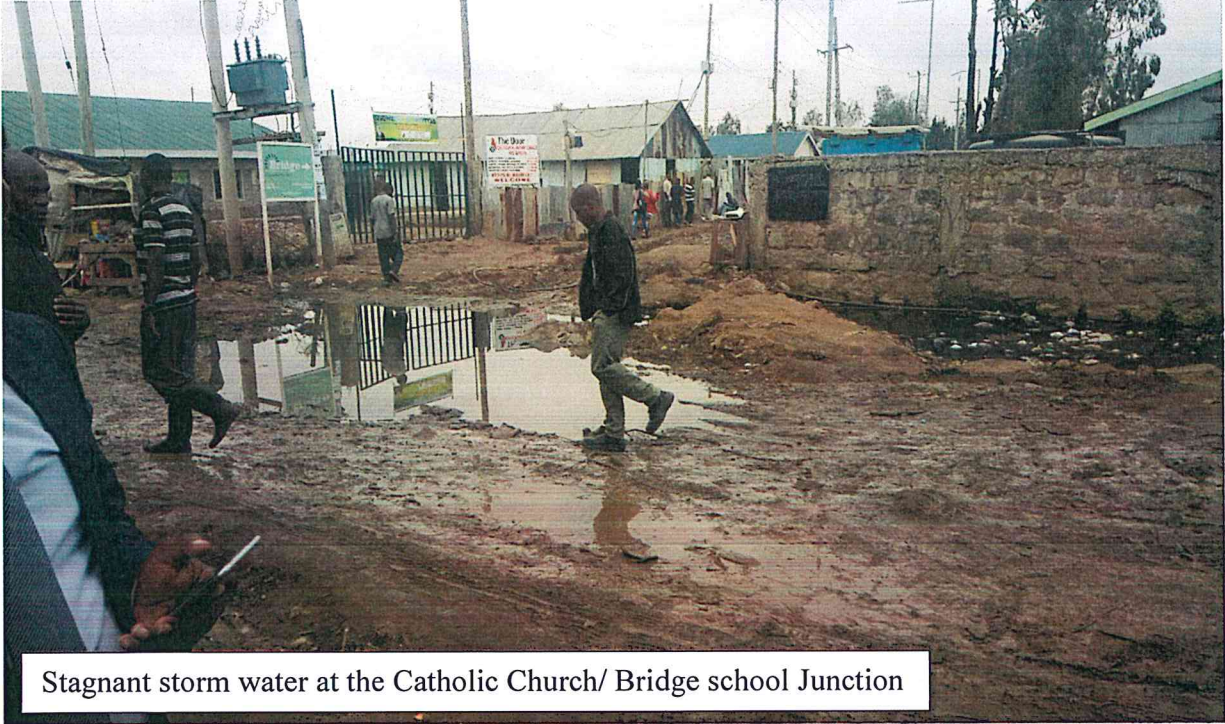
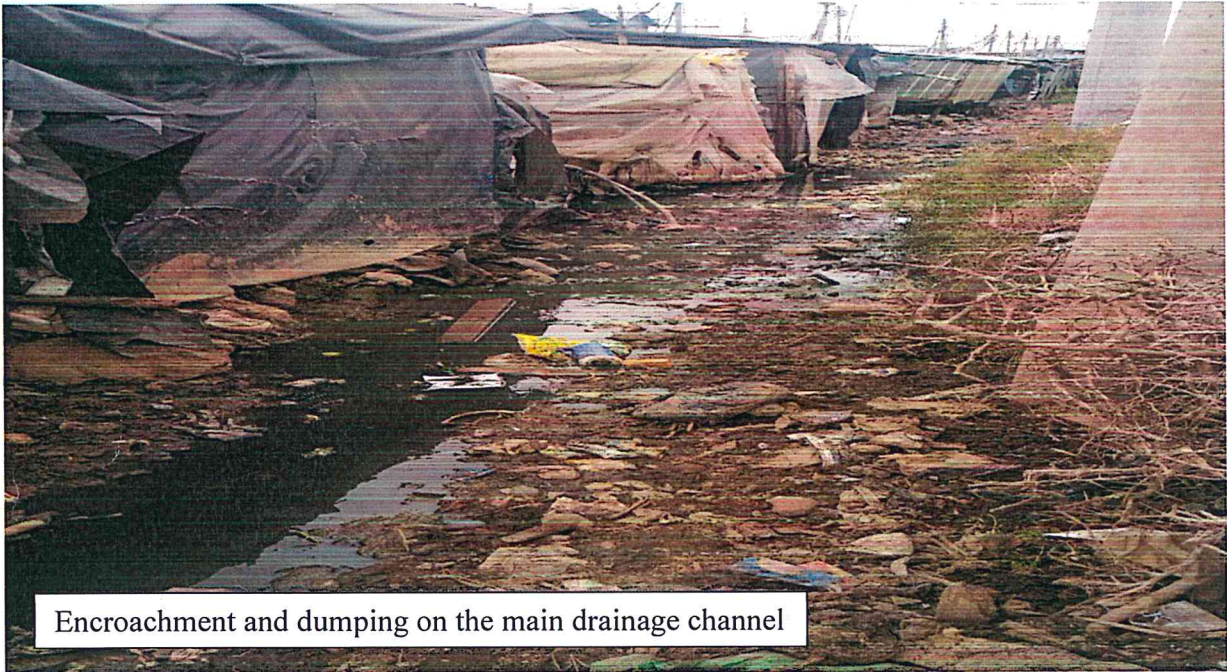
- i. At St. Jude Thaddeus Reuben Catholic Church Junction, the drainage system was unable to channel storm water to the river due to blockage by loose soil and garbage. As a result, storm water was unable to flow downstream;

- i. The County Government to move with speed to construct proper drainage in the affected sections of Kwa Reuben, Umoja 1 and Komarock Wards;
- ii. The County Government to urgently clear all blocked drainage systems in Kwa Reuben Ward and ensure that stagnant storm water in social amenities is drained accordingly;

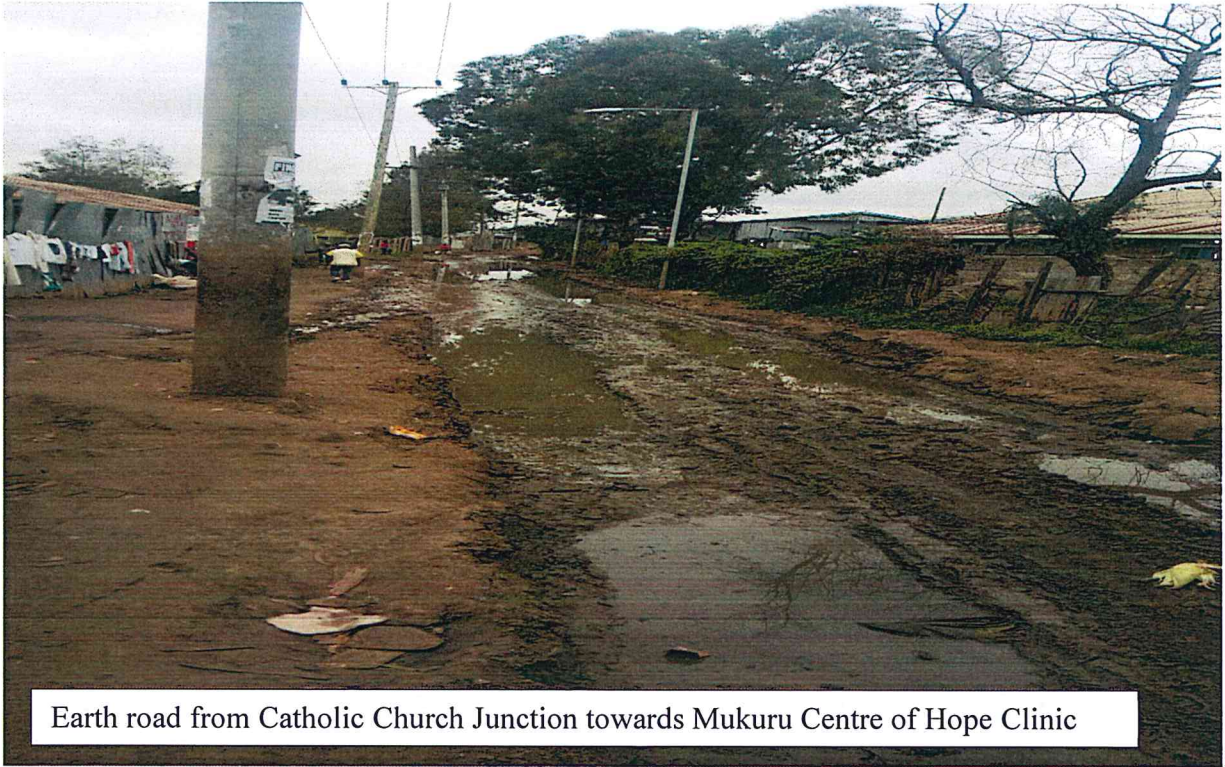
- ii. The earth feeder road leading to Mukuru Centre of Hope and Amua Family Planning Clinics from the Catholic Church Junction had been rendered impassible by stagnant storm water that drains onto the road due to the blocked drainage system at the Junction;

Earth road from Catholic Church Junction towards Mukuru Centre of Hope Clinic

- iii. The County Government to urgently rehabilitate earth roads damaged by storm water resulting from the recent long rains in Kwa Reuben Ward;
- iv. The County to clear all encroachments on drainage including solid waste systems on County roads especially in Kwa Reuben Ward to ensure continuous flow of storm water into major drainage channels;

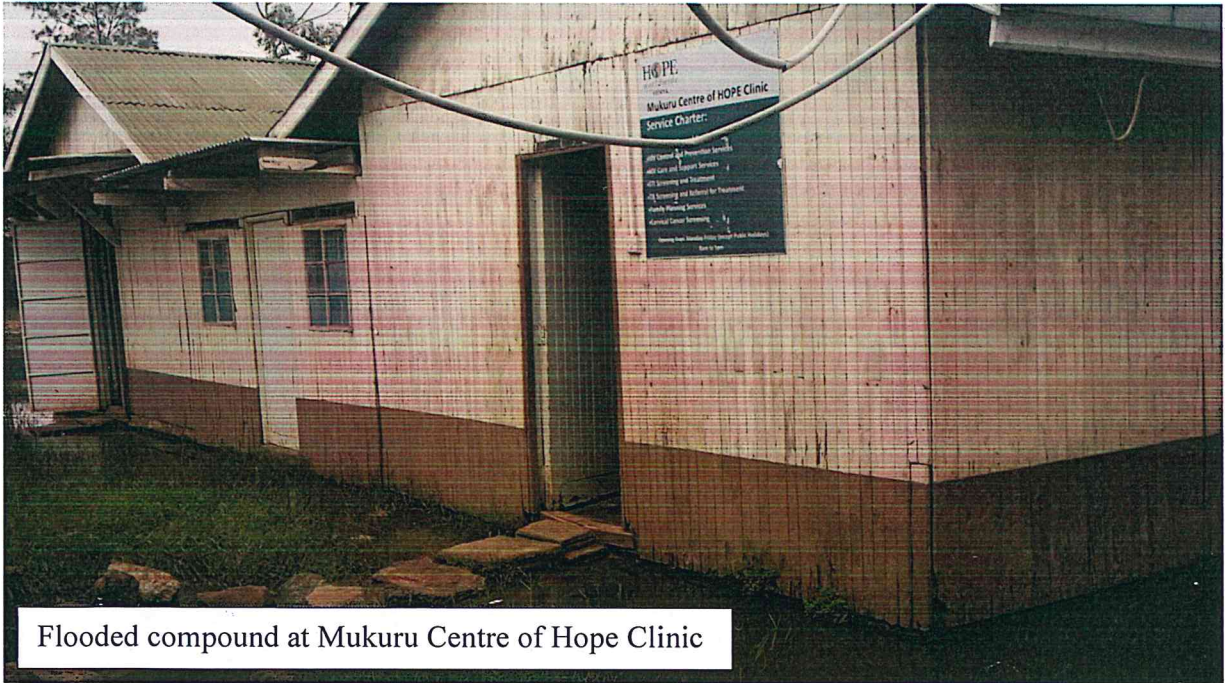
- iii. Mukuru Centre of Hope and Amua Family Planning Clinics were flooded by the overflowing storm water from the feeder road named above and that the stagnant water in the facility was partly submerged most of the buildings in the compound leaving them unutilized;

Flooded compound at Mukuru Centre of Hope Clinic

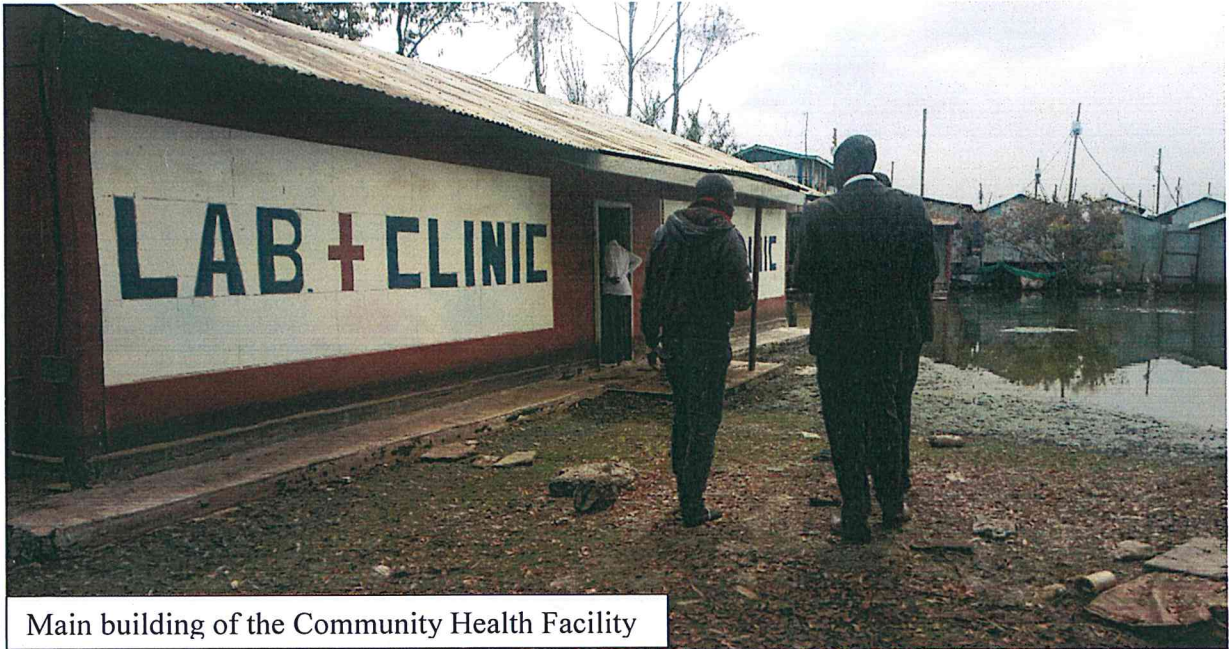
- iv. The overall drainage in the settlement was poor hence most houses are surrounded by stagnant water mixed with poorly disposed garbage; and
- v. The Mukuru Community Health Centre had been closed down owing to storm water that partly submerged the buildings allegedly because the storm water channel was blocked by construction of residential housing on public land adjacent to the facility;

Main building of the Community Health Facility

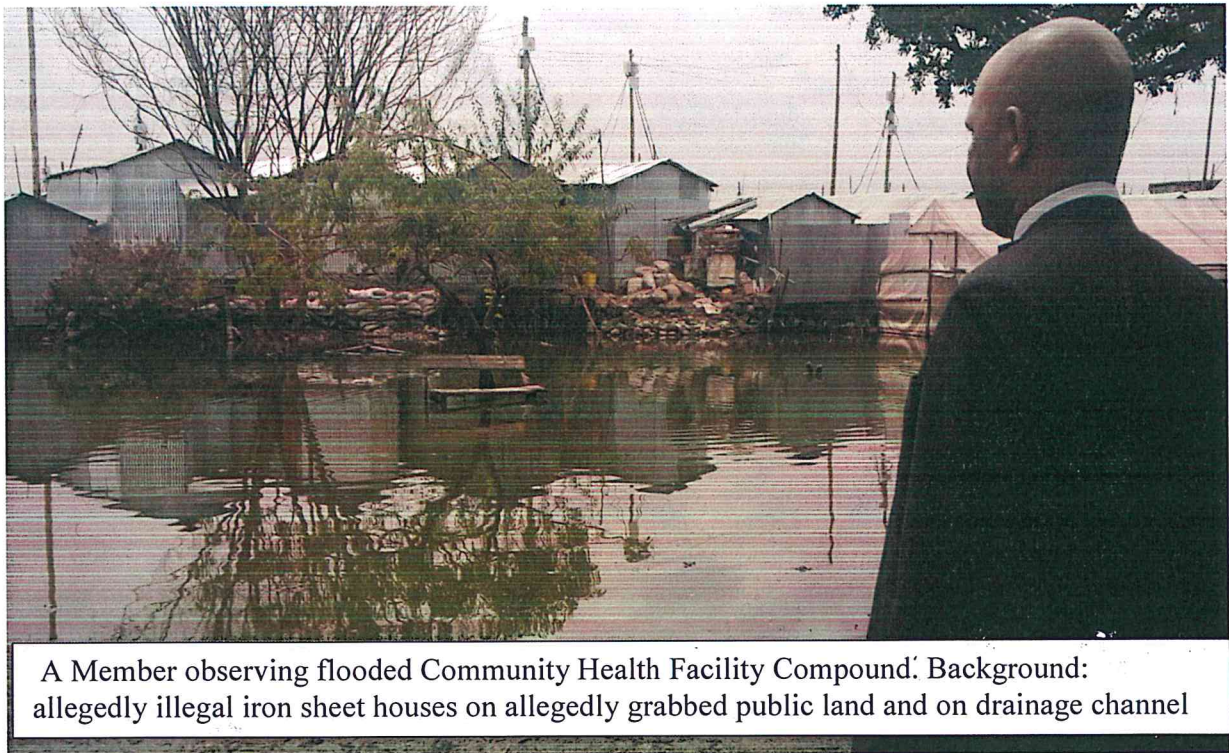
A Member observing flooded Community Health Facility Compound. Background: allegedly illegal iron sheet houses on allegedly grabbed public land and on drainage channel

- vii. The County Assembly Sectoral Committee on Planning and Housing to investigate the circumstances under which the land adjacent to Kwa Reuben Community Health Centre was allegedly grabbed and unprocedurally developed and subsequently interfering with flow of storm water in sections of the Ward with a view of reverting it to the County.

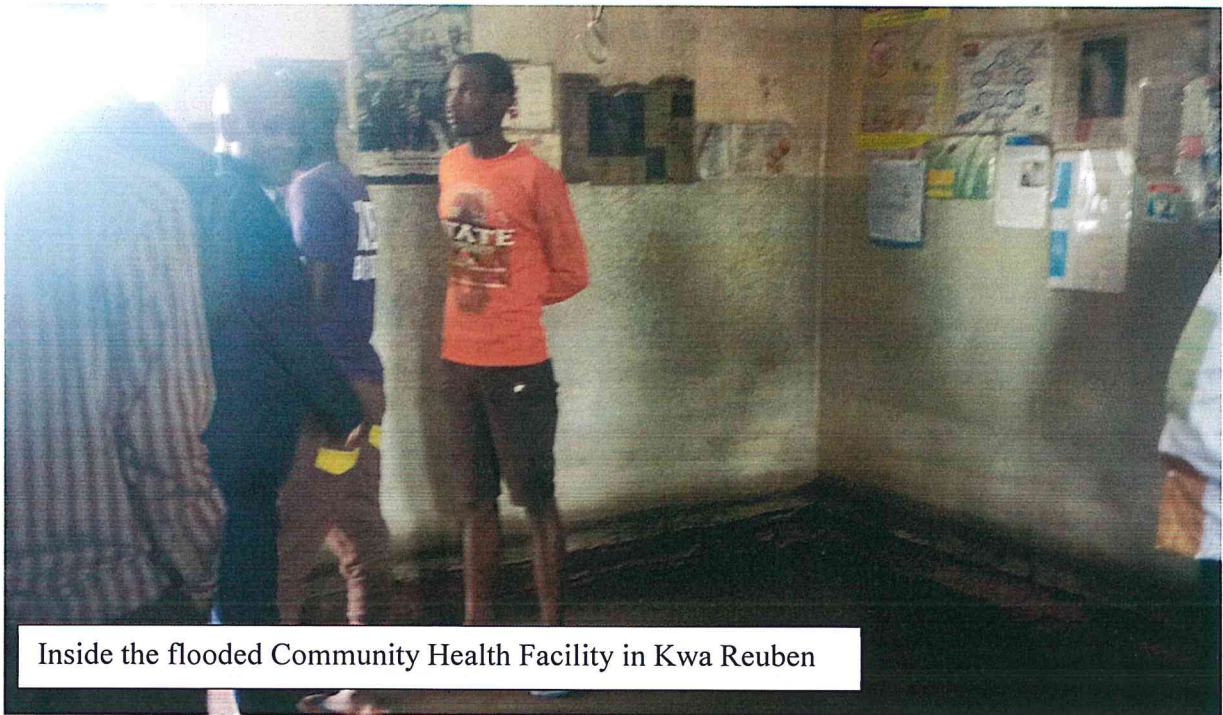
Inside the flooded Community Health Facility in Kwa Reuben

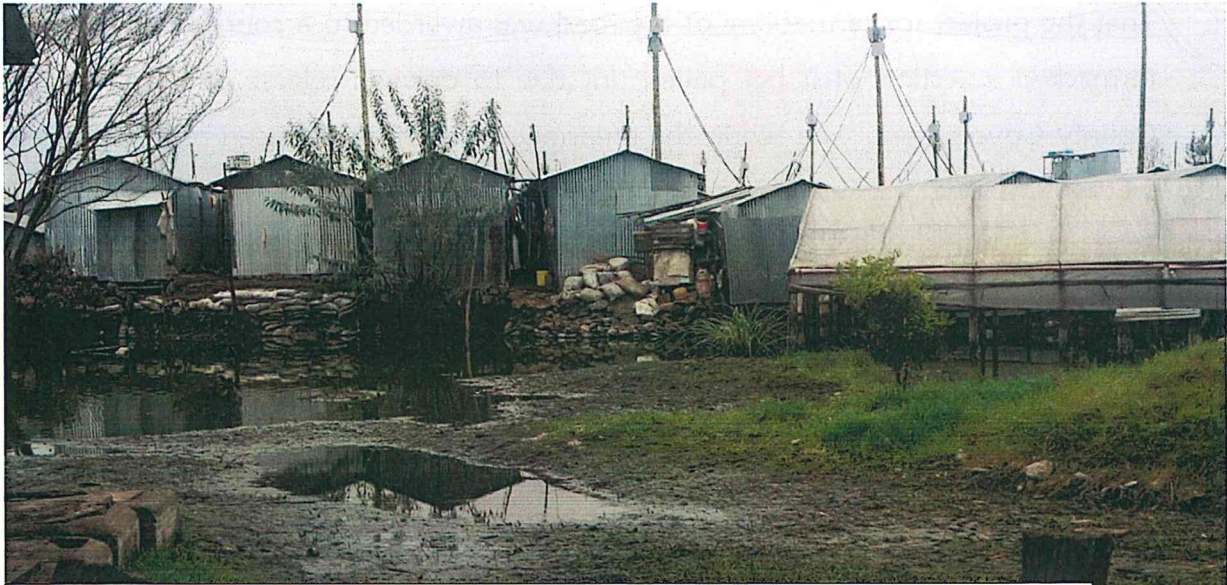
Development on allegedly grabbed public land in Kwa Reuben

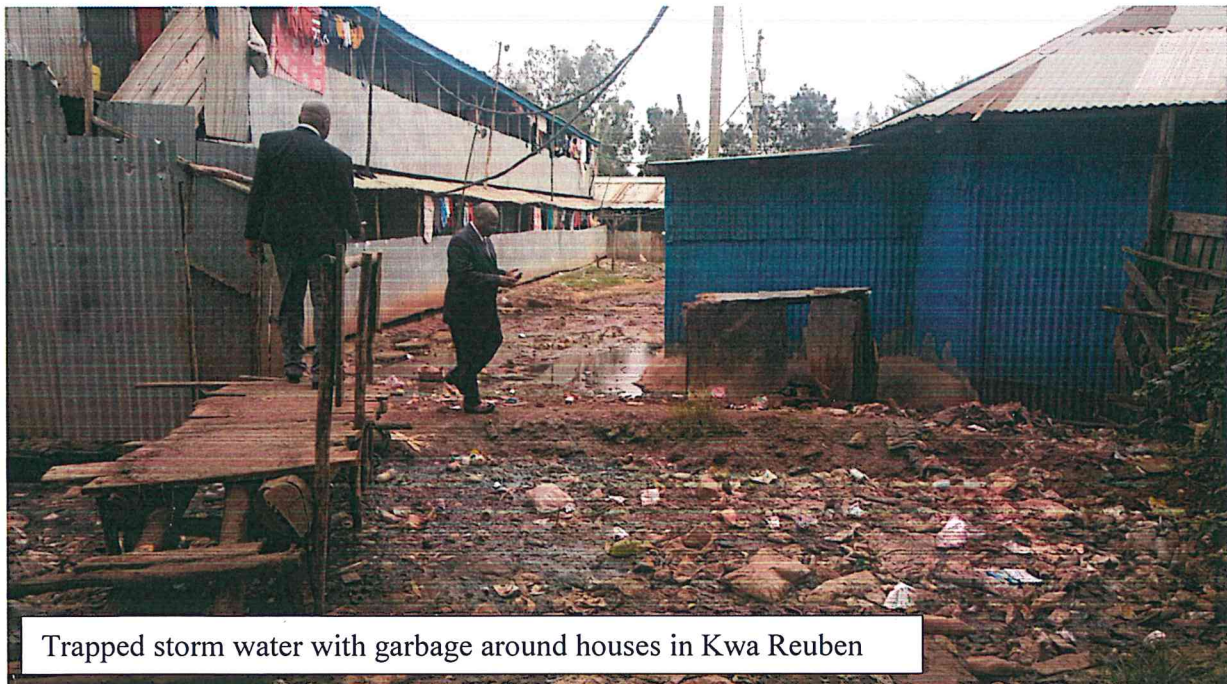
Trapped storm water with garbage around houses in Kwa Reuben

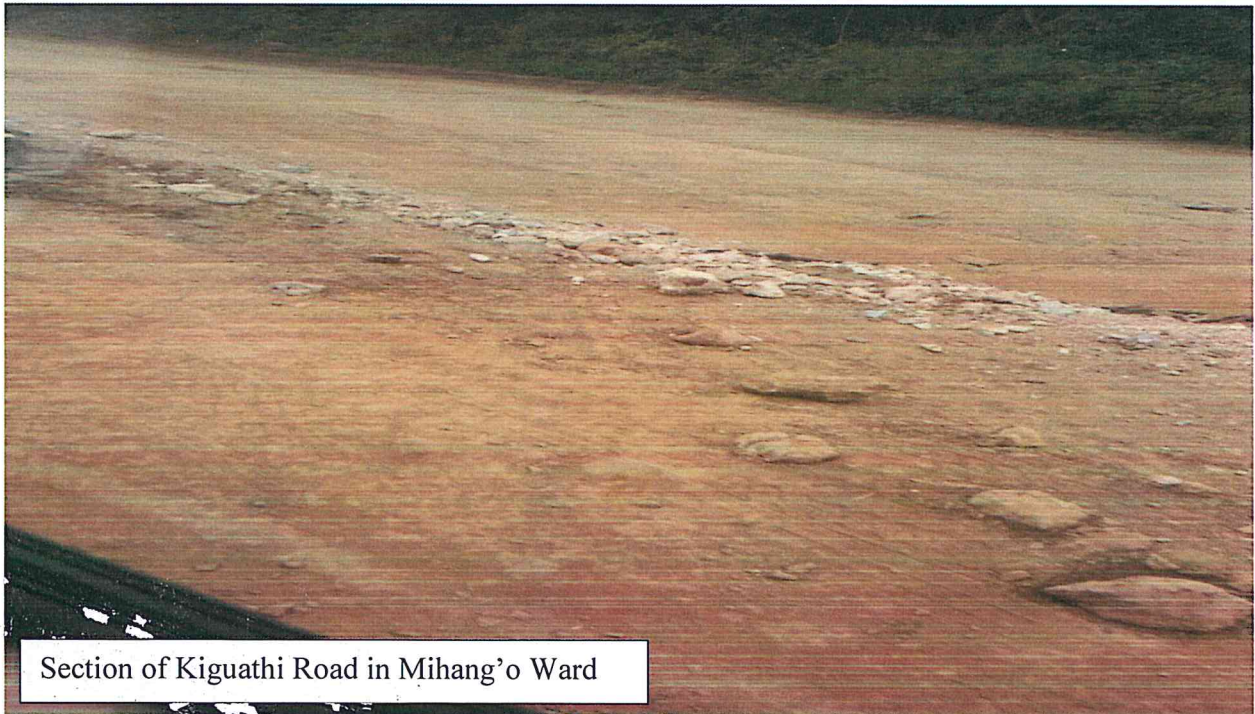
- i. That the project for tarmacking of the road was awarded to a contractor who had tarmacked a section of it but pulled out due to delayed release of funds by the County Government. As a result, the untarmacked section had been damaged by the rains; and
- ii. That completion of the project had however, been allocated Ksh. 60,300,525 in the FY 2018/2019 budget.

- v. The County to expedite release of funds to the contractor working on Kiguathi road in Mihang'o Ward so that works resume on the road; and
- vi. The County to tarmac the SDA-Kirwa Club and Pewa Street- AIC roads in Umoja 1 Ward. Further, damaged roads in Umoja estate to be factored in the 2018/2019 Annual Maintenance Plan in view of rehabilitating them to ease mobility of both humans and motor vehicles; and

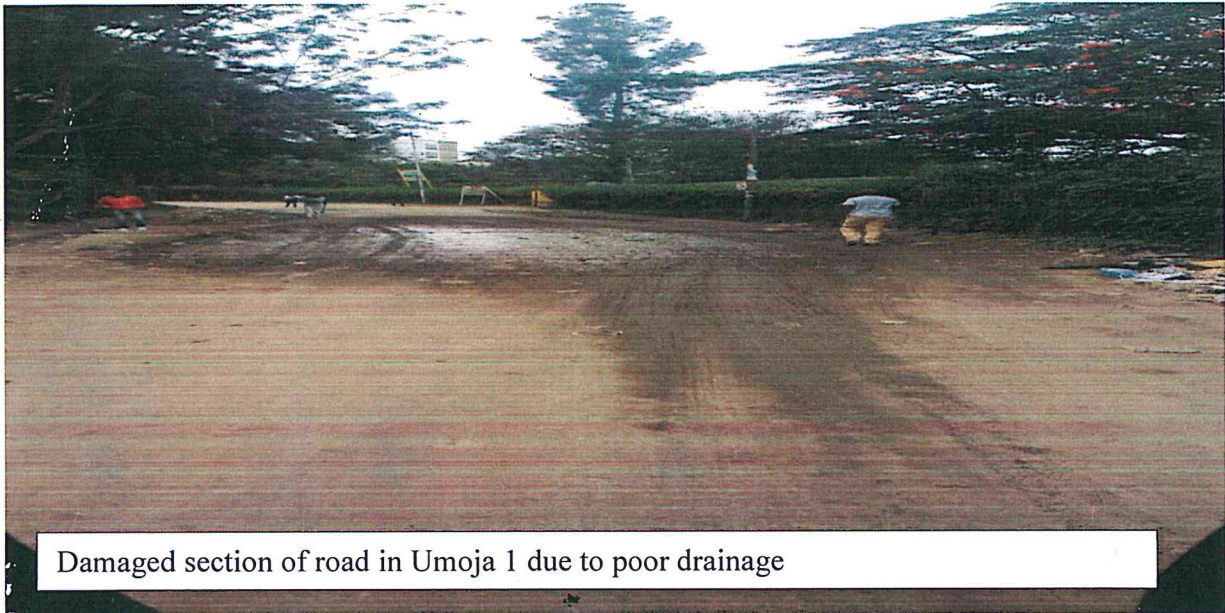
1. That drainage along the road leading to Umoja 1 Primary School and the adjacent residences was poor. This led to development of potholes in the road due to stagnant water the road;
2. That the Seventh Adventist Church (SDA)- Kirua Club road and Pewa Street- African Inland Church(AIC) Link earth roads were rendered muddy and impassible to pedestrians. While motorists found it difficult to navigate due to the muddy conditions.

Damaged section of road in Umoja 1 due to poor drainage

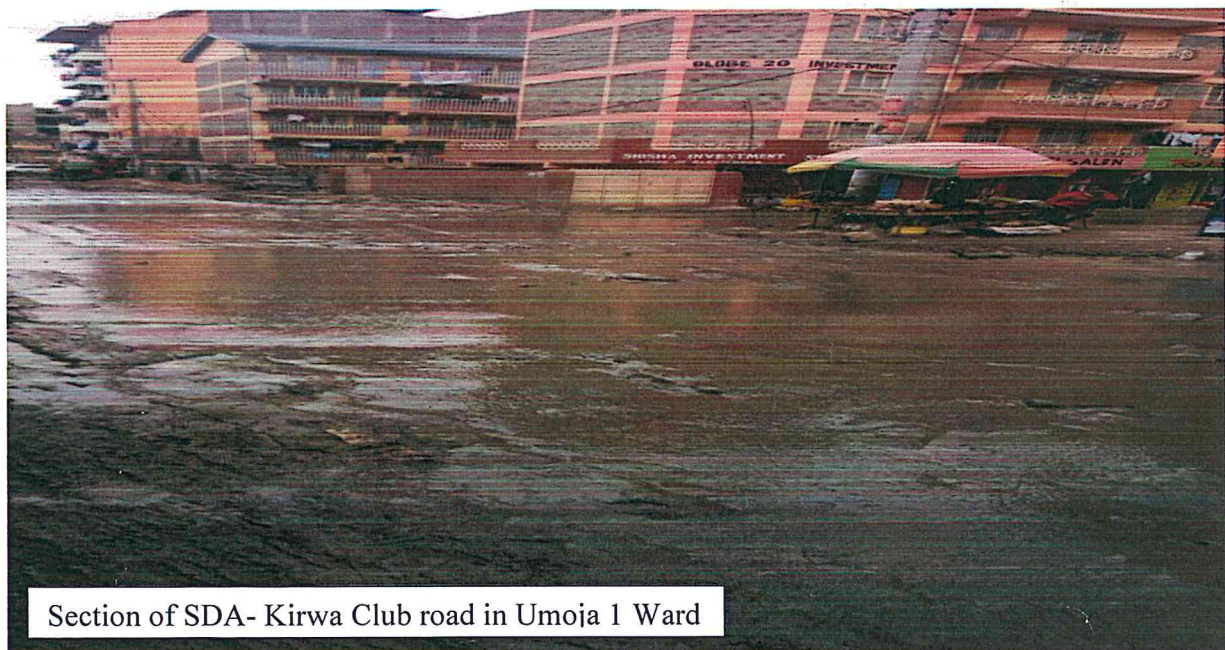
Section of SDA- Kirwa Club road in Umoja 1 Ward
